Mitsubishi Motors Development Engineers Reveal Their PHEV Problems

Naoshige Shimizu
Nikkei Automotive Technology

Part 1: Causes of the Mitsubishi Outlander PHEV's Battery Combustion Accidents, and Their Solutions

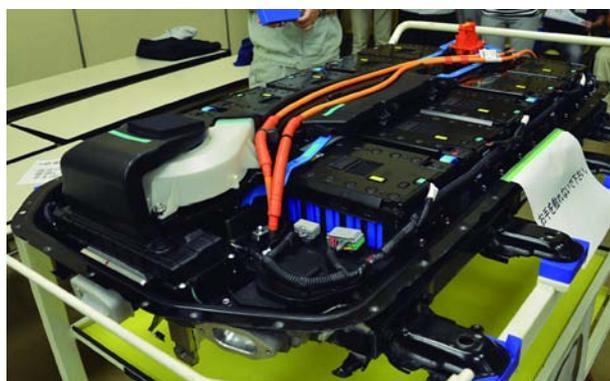
The Mitsubishi Outlander PHEV's Li-Ion secondary batteries have experienced overheating and combustion. After analyzing various factors, two causes have emerged: damage caused by the unintended dropping of the batteries while on the production line, and the misconfiguration of measuring instruments. These issues were properly corrected, resolving the battery problems, though numerous failures within the software have also been reported. An overarching theme behind these issues is that despite in the rapidly advancing electrification and computerization of automobiles, auto manufacturers approached EV development with a conventional development mindset. There was insufficient communication between engineers in different technological fields.

Mitsubishi Motors released the “Outlander PHEV” plug-in hybrid electric vehicle at the end of January in 2013 (**Fig. 1**). The electrodes of the vehicle’s Li-ion secondary battery cell short-circuited, causing the battery pack to erode and combust. (**Fig. 2**). Independent of this battery problem, numerous defects also surfaced with regard to the vehicle’s control software; so far, Mitsubishi has reported two recalls to the Japan Ministry of Land, Infrastructure, Transport and Tourism (MLIT), and has initiated three service campaigns. The company held two press conferences in April 2013 to explain the background and causes of the incidents after they found the battery defects. In July, the company invited the public to observe the operations replacing the recalled batteries.

Fig. 2 An overheated and combusted Li-ion secondary battery after shipment

The battery pack to be installed on the Outlander PHEV
